Docket No. 217 – Development and Management Plan Inspection

Northeast Utilities Service Company Certificate of Environmental Compatibility and Public Need for the construction of a 345-kV electric transmission line and reconstruction of an existing 115-kV electric transmission line between Connecticut Light and Power Company's Plumtree Substation in Bethel, through the towns of Redding, Weston, and Wilton, and to the Norwalk Substation in Norwalk, Connecticut.

Date: May 4, 2006

Location: 345kV Underground Route

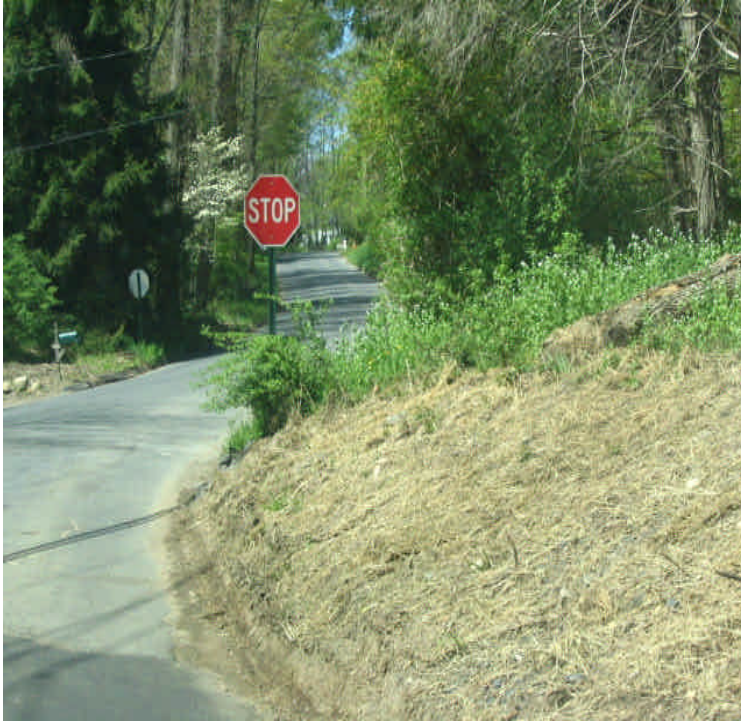
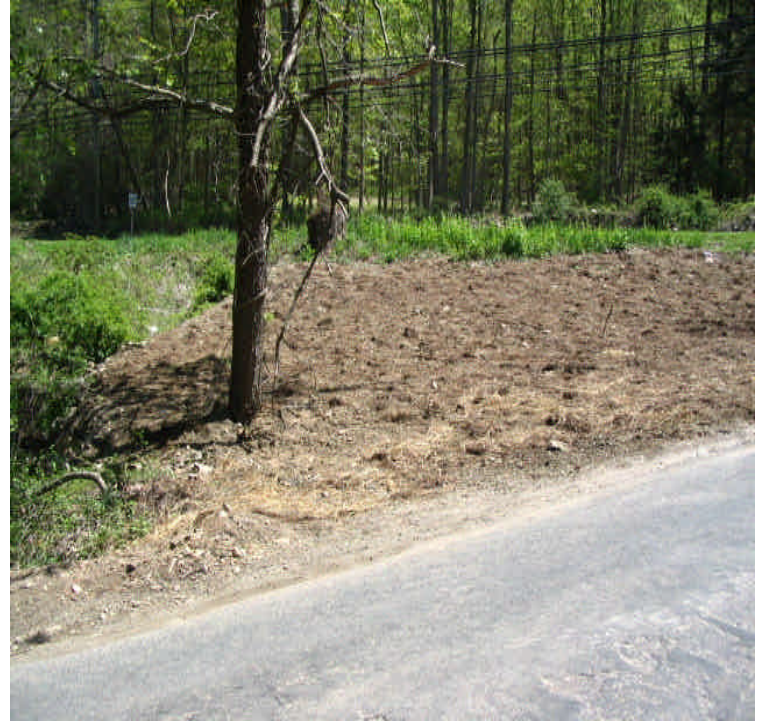
345kV (Umpawaug Rd): Photo on the left shows recently restored roadway slopes along Umpawaug Rd. Areas are stabilizing and starting to show grass growth. Photo on the right shows where the small storage area at the Rt 107 intersection was mulched and seeded. 5/4/06

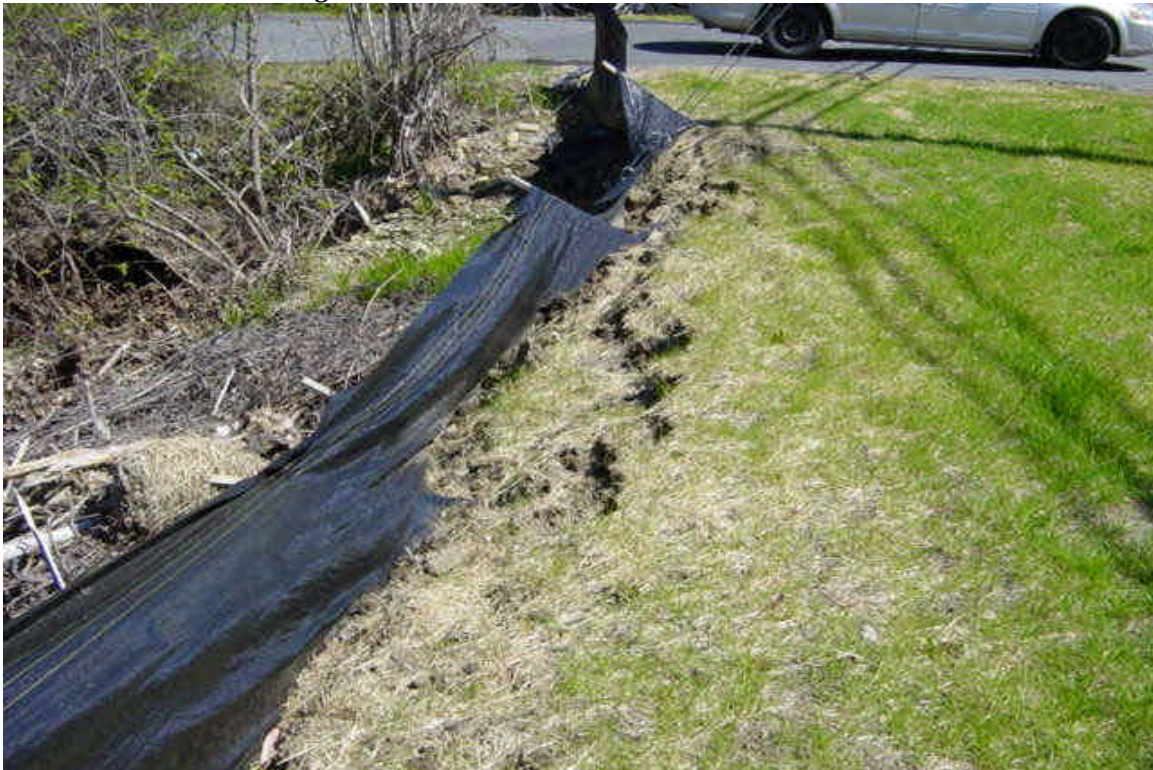
345kV (Georgetown Deli) Photo shows where the bank along the stream is beginning to slump and erode following the heavy rains. Further stabilization is needed although the surrounding area looks good. 5/4/06

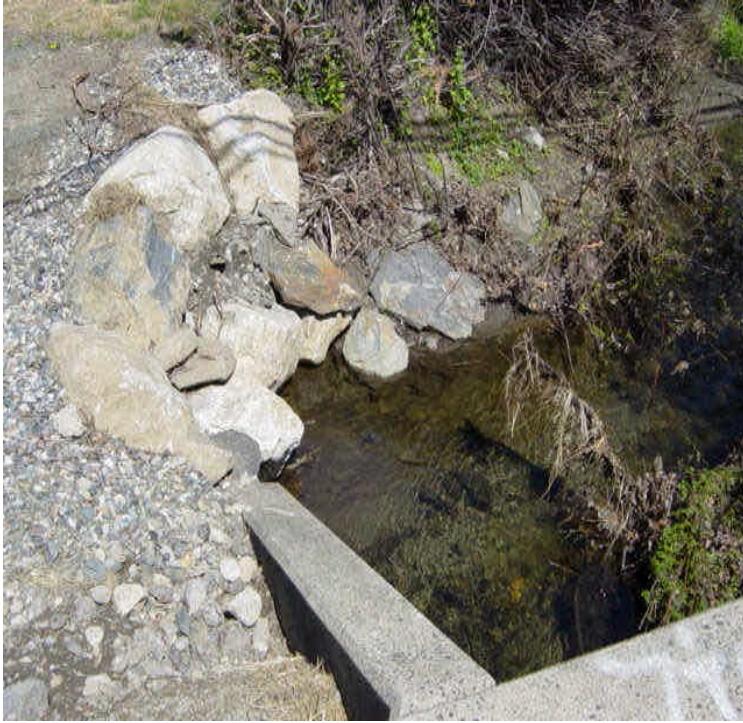
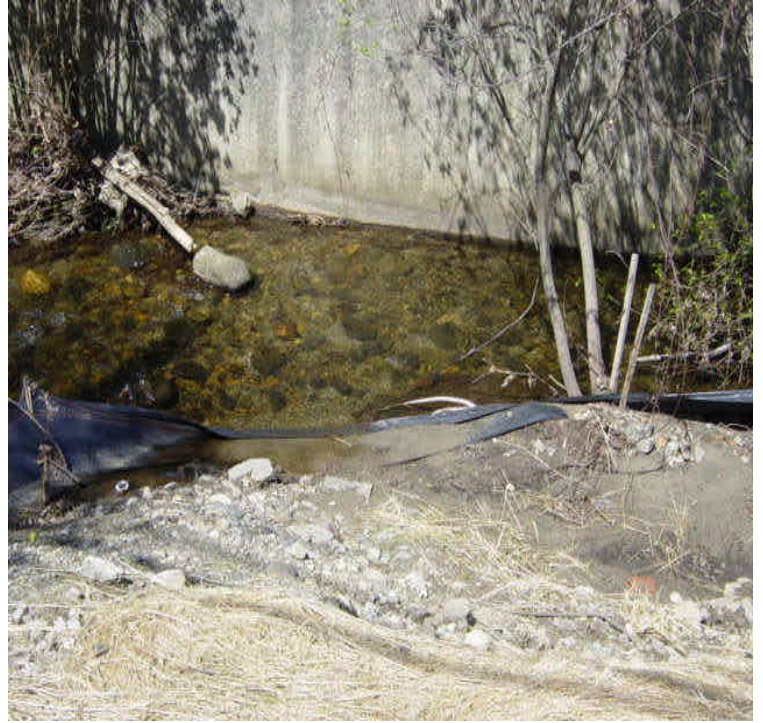
Photo on the left shows the bank of the stream moving south. Additional restoration efforts should be made hereto promote vegetation. Photo on the right shows where the heavy rains had caused a washout at the base of the slope. 5/4/06

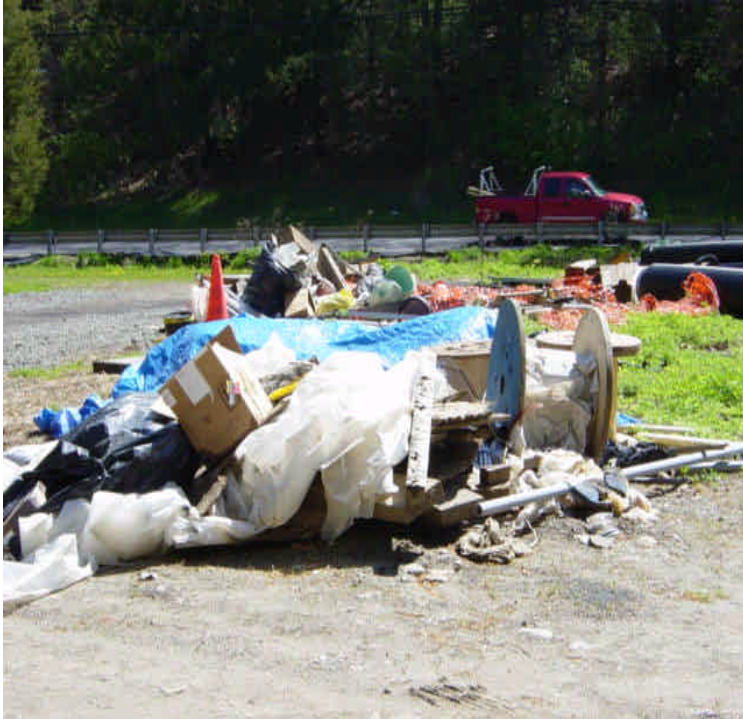
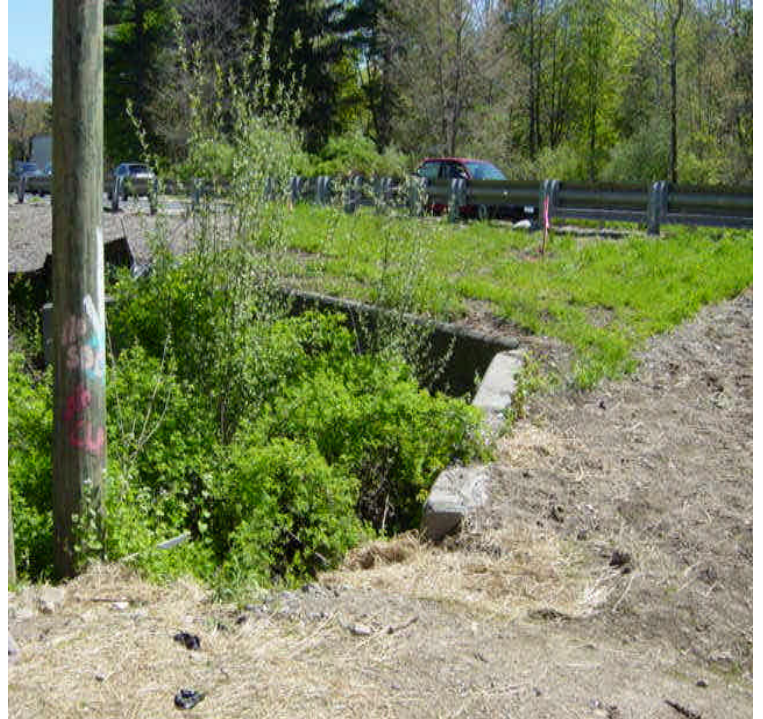
345kV (Rt 7) Photo on the left shows the storage area near the intersection of Rts 107 and 7. Continue to provide "good housekeeping" when feasible. Photo on the right shows the Wilton HS J&B area where silt fence was removed. The area will likely need further restoration efforts. 5/4/06

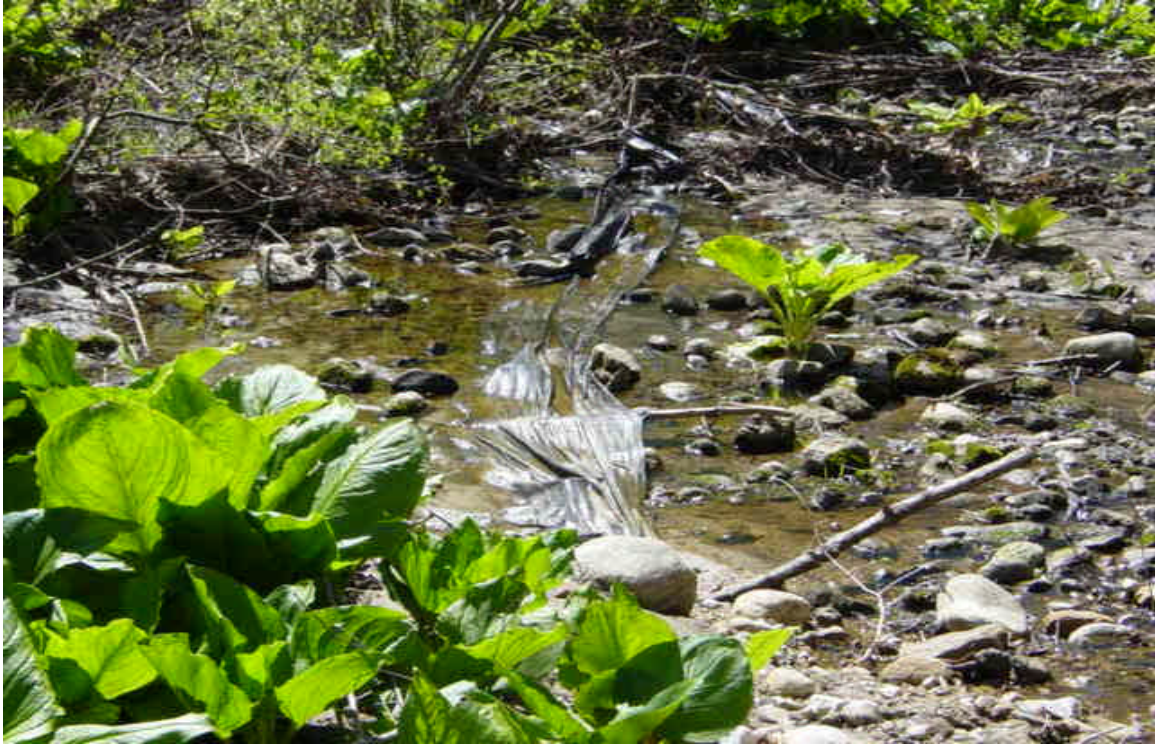
345kV (HDD) Photo shows the wetland area beyond the basin where the silt fence was pushed over due to the recent rains. Sediment deposits also remain here and will need to be removed carefully by hand. 5/4/06

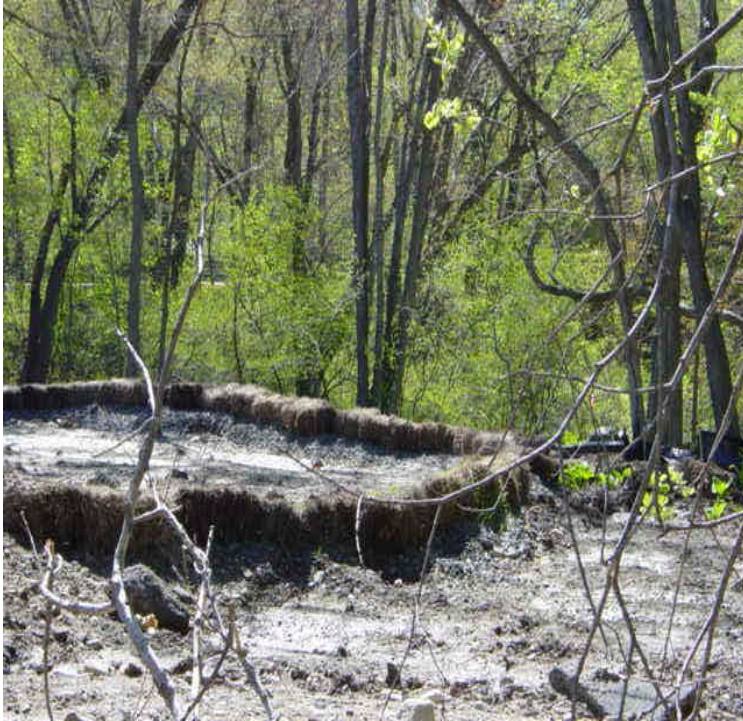
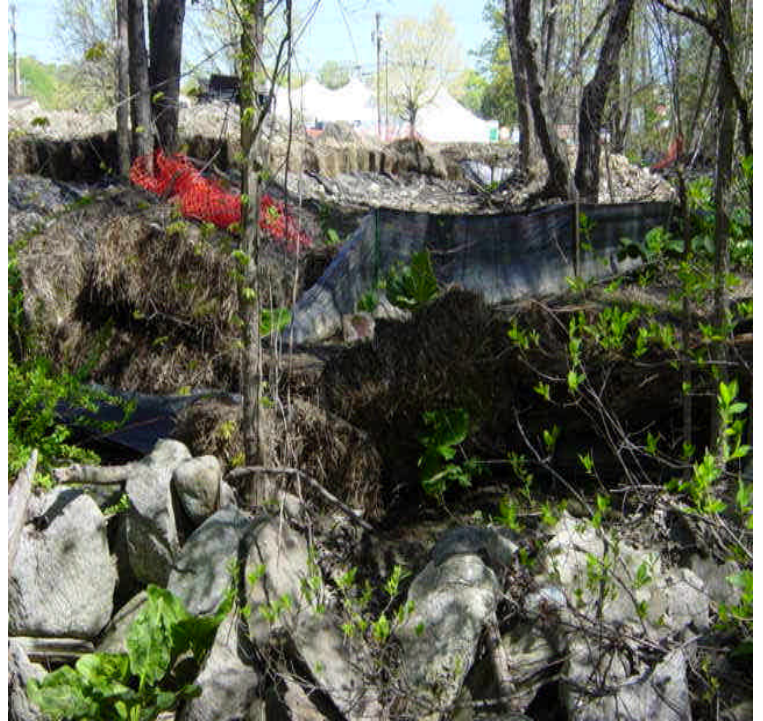
Photo on the left shows a view of the remaining berm area and erosion controls. The entire area will be regraded when work here is complete. Photo on the right shows the status of the controls beyond the basin. Controls will be replaced when the area is graded. 5/4/06
